MODIFICATION INSTRUCTIONS

KODAK MINILOADER 1

MODIFICATION No. M31

PURPOSE:

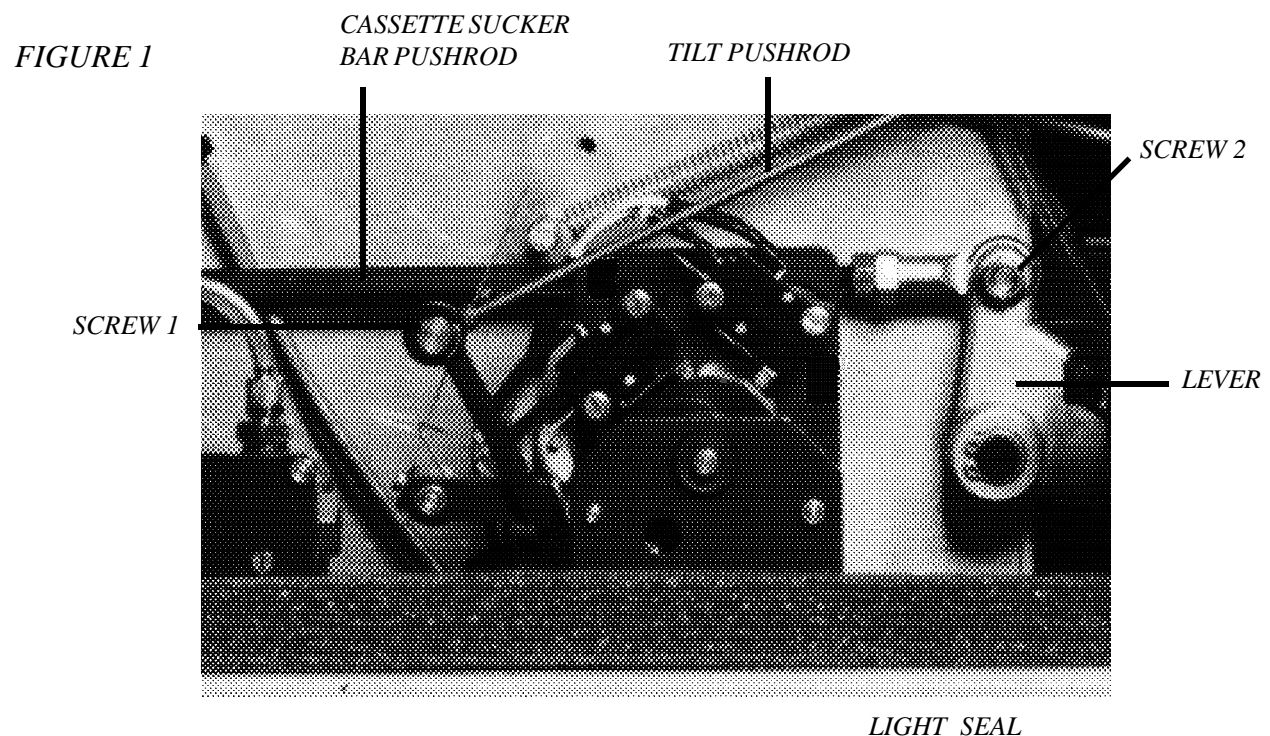
1. Switch off the MINILOADER, and remove the TOP COVER and the left (looking from the front) SIDE PANEL.
2. Disconnect the TILT PUSH ROD by removing the M4 SCREW (SCREW 1 in FIGURE 1) on the TILT LINKAGE.
3. Disconnect the CASSETTE SUCKER BAR PUSH ROD by removing the SCREW (SCREW 2 in FIGURE 1) from the LEVER. CAUTION - support the SUCKER BAR as you remove the SCREW, and gently lower the SUCKER BAR to the CASSETTE CONVEYOR BELT as it becomes loose. Do not attempt to disconnect the CASSETTE SUCKER BAR PUSH ROD by unscrewing the PUSH ROD, as you will destroy the adjustment.

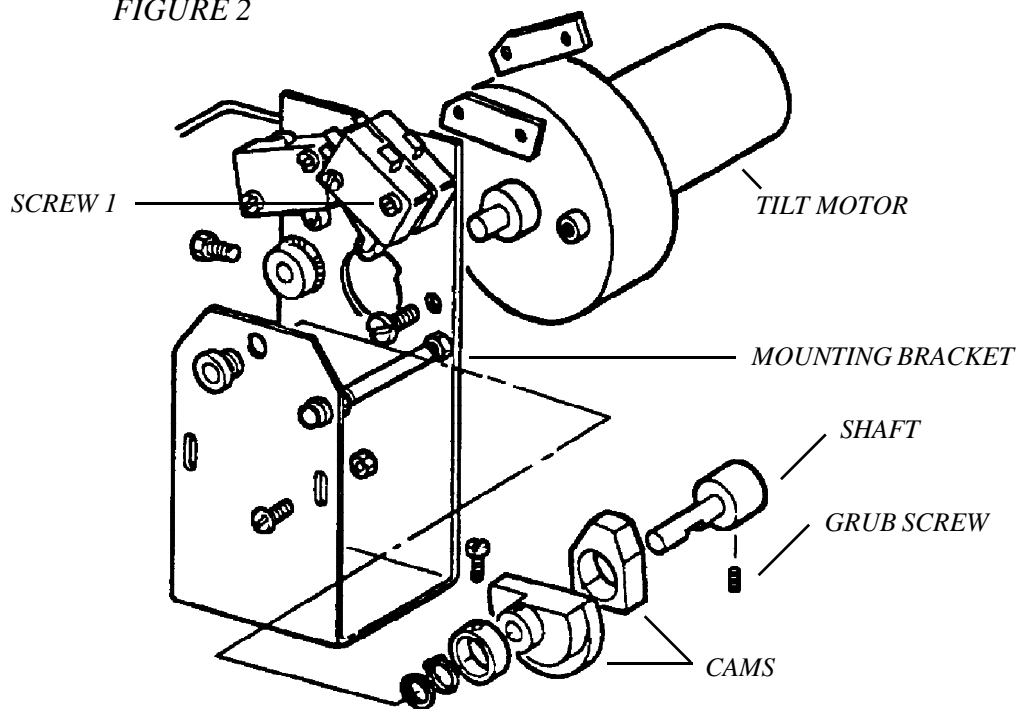
FIGURE 2

6. Remove the SCREW (1 in FIGURE 2) that retains the two MICROSWITCHES, and then rotate the MICROSWITCHES away from the CAM ASSEMBLY.

7. Remove the three SCREWS that secure the TILT MOTOR to the MOUNTING BRACKET. Hold the CAM FOLLOWERS away from the CAMS and withdraw the TILT MOTOR. The hole in the MOUNTING BRACKET is profiled to allow the withdrawal.
8. Change the existing SHAFT for the new SHAFT, reusing the GRUB SCREW. The new SHAFT has the FLAT for the MICROSWITCH operating CAM advanced by 15 degrees compared to the old SHAFT. This ensures the MICROSWITCHES are operated earlier. Reassemble the TILT MOTOR on the MOUNTING BRACKET.
9. Replace the MICROSWITCH MOUNTING SCREW, and adjust the MICROSWITCHES so the SWITCHES are not bottomed as the CAMS rotate.
10. Refit the TILT MOTOR ASSEMBLY in the MINILOADER and refit the LIGHT SEAL.
11. Refit the CASSETTE SUCKER BAR PUSH ROD onto the LEVER.
